# Aquatic Resources Report

## ***Mullan BUILD Project***

*Missoula County, Montana*

**October 8, 2020**

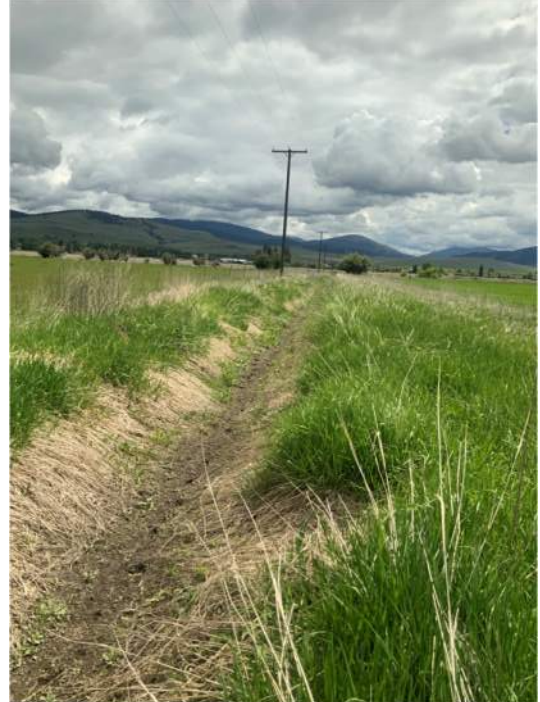
Photo 10. Lateral 1 of Flynn-Lowney Ditch at the proposed George Elmer Drive crossing, looking east.

This ditch is a narrow lateral ditch ranging approximately 3 to 6 feet in width that begins at a diversion of the Flynn-Lowney Ditch just west of George Elmer Drive. The lateral ditch flows in a northerly direction for approximately 170 feet, turns west for 880 feet, flows north for 0.25 mile, then flows west approximately 0.5 mile into Grant Creek. This lateral is crossed by the project by the proposed Tipperary Way Trail and the proposed extension of England Boulevard and George Elmer Drive. The north-south segment of the ditch that is crossed by the proposed extension of England Boulevard contained water during the field investigation, although the ditch was not flowing. The east-west segment of the ditch crossed by the proposed extension of George Elmer Drive did not contain water during the field investigation.
